ASTM E84-95

**SURFACE BURNING
CHARACTERISTICS**

Glasbord Kemply FRP Skin (.050")

Report No. 9013 - 100954

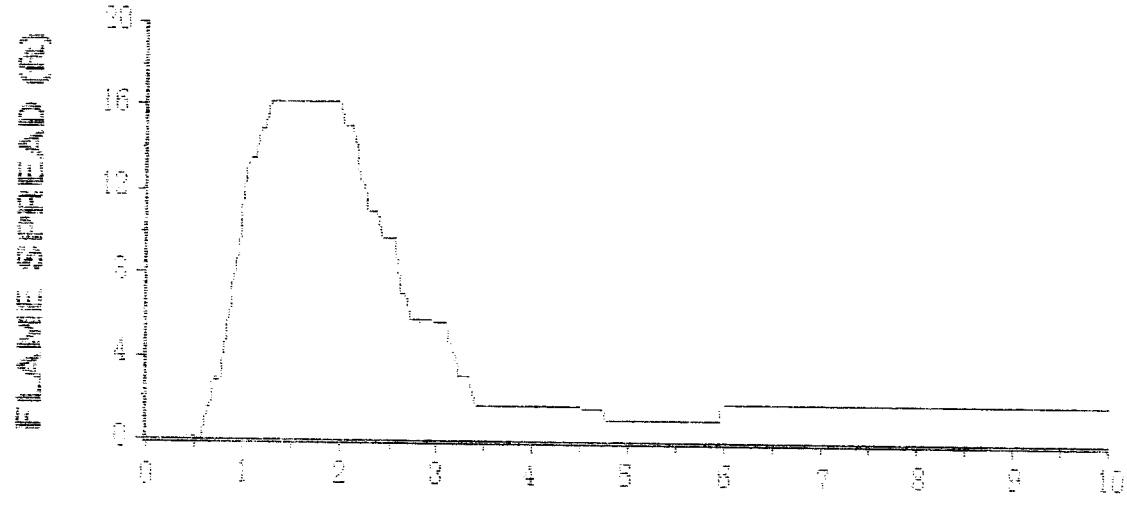
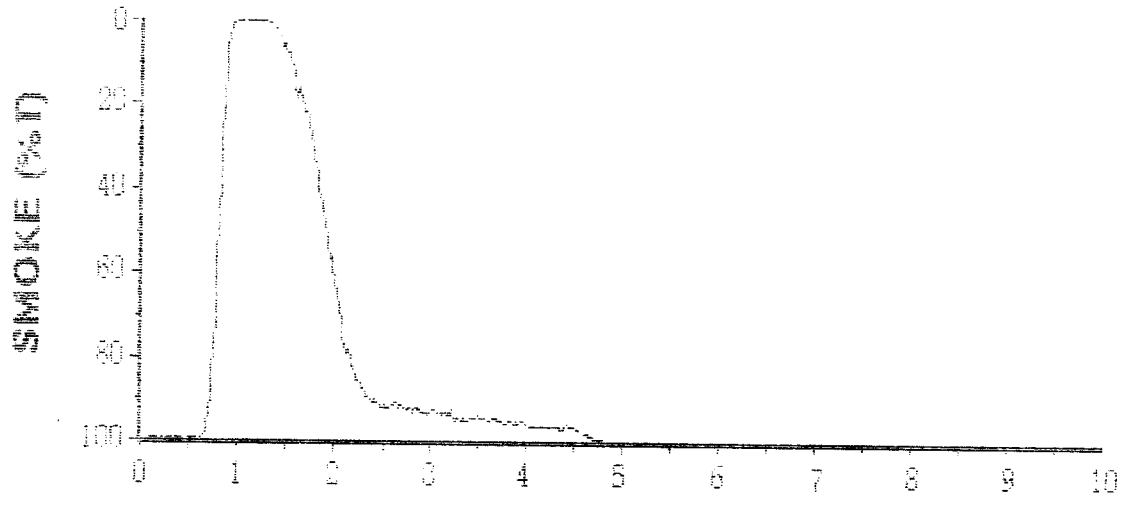
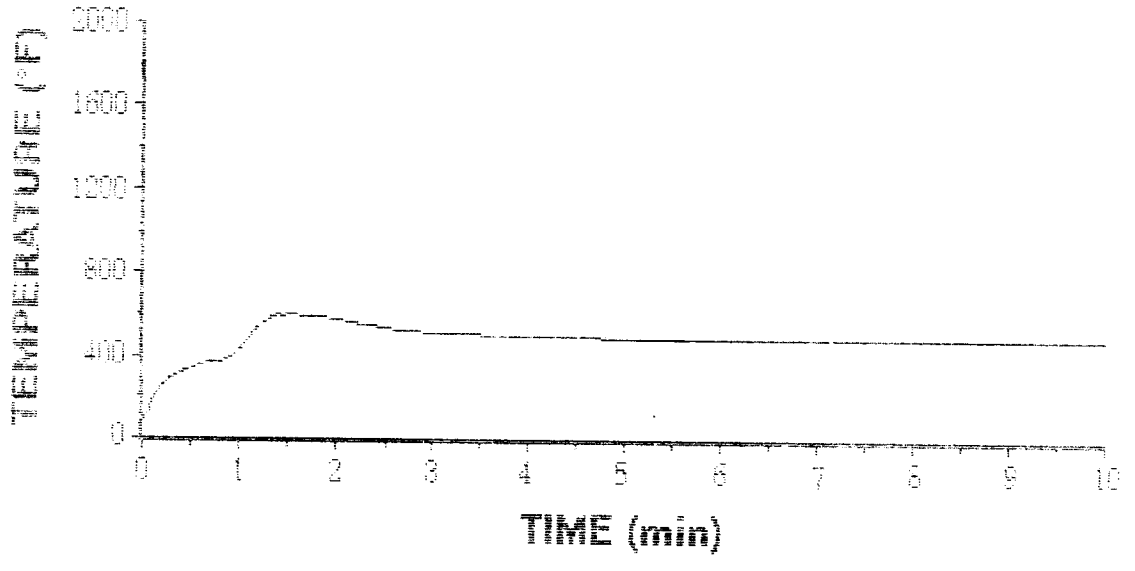
DATA SHEETS

The data sheets are included in the Appendix. These sheets are actual print-outs of the computerized data system which monitors the ASTM E84 apparatus, and contain all calibration and specimen data needed to calculate the test results.

While no longer a part of this standard test method, the Fuel Contributed Value has been computed, and may be found on the computer printout sheet in the Appendix.
